Reserves at Chesterfield Village Chesterfield, Missouri

Case Study

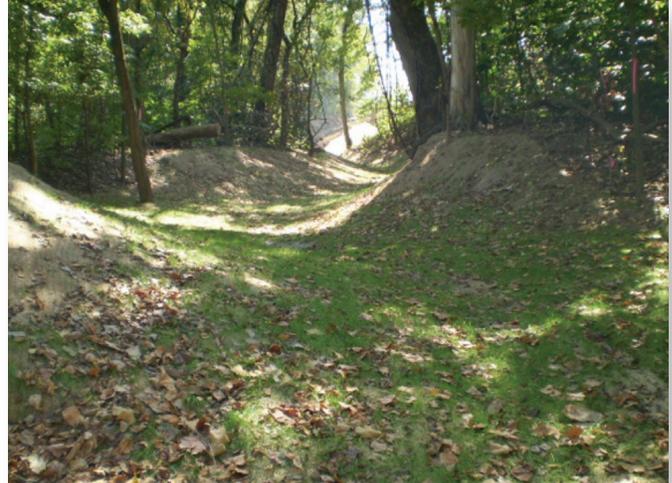
Once vegetated the PS42 TRM is not visible but still provides significant and permanent erosion control and vegetation reinforcement.

In successive years the TRM reinforced vegetation is still lush and successful on the site and continues to provide excellent erosion control and aesthetics on the site.

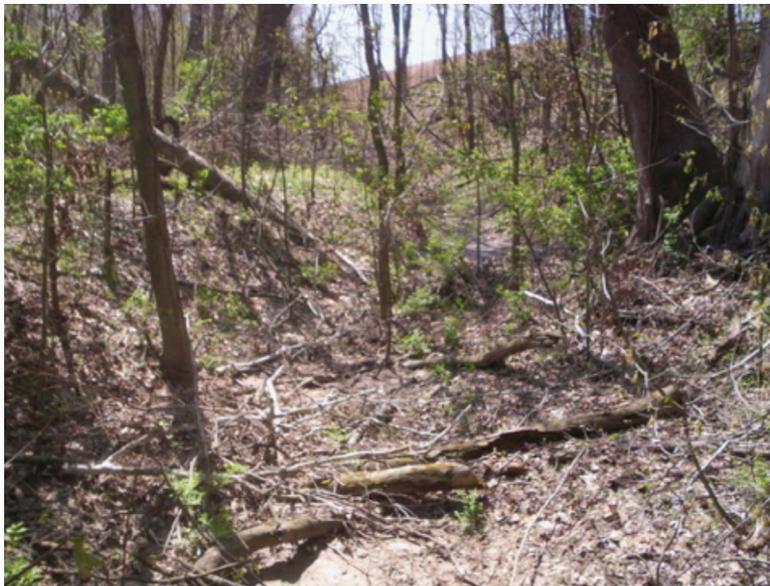
Previous attempts at using unreinforced vegetation had failed on the site.

points into the creek concentrated stormwater and increased the risk of significant erosion on the site. Previous attempts at erosion control using unreinforced vegetation and rock rip rap had failed and been unsightly.

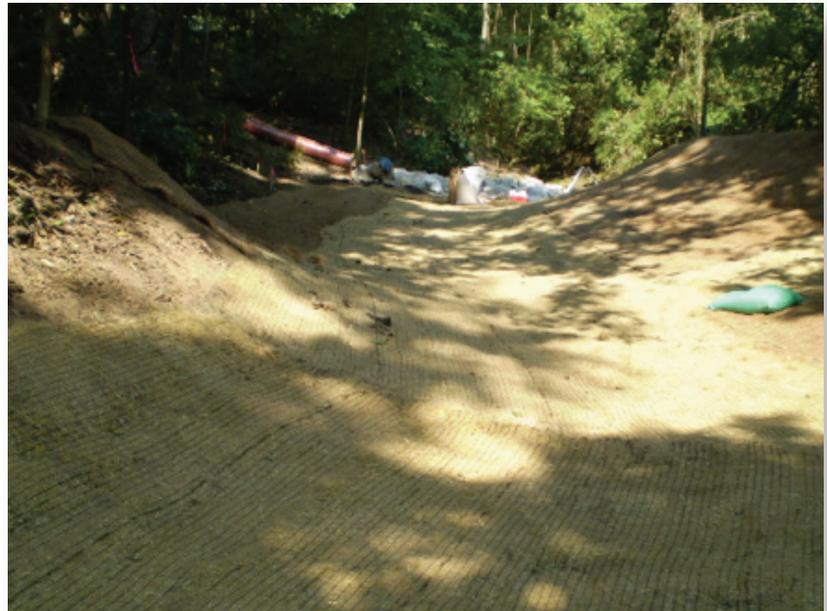
PS42 TRM comes in a natural tan color and installs quickly and simply.

The PS42 TRM was chosen for a variety of reasons. It provided immediate erosion control to the site while also promoting quick germination thanks to the component of straw fibers added to the permanent TRM structure. It also installed faster and cost significantly less than other TRM options that required complex anchoring systems or various soil filling requirements. In addition, the PS42 TRM comes in 16' width, which not only made for faster installation, but significantly decreased the number of seams required.
