Waste Management Landfill Austin, TX

Case Study

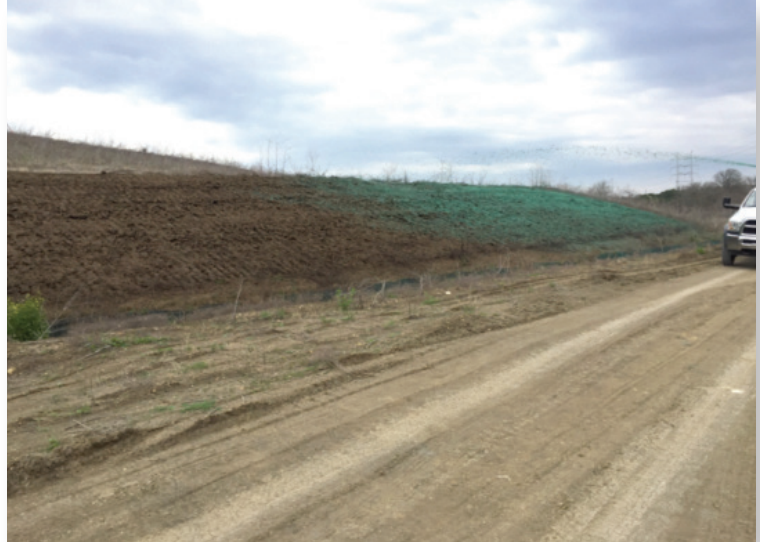
Installation of biotic Earth March 2018, covered with an FGM within the hour.

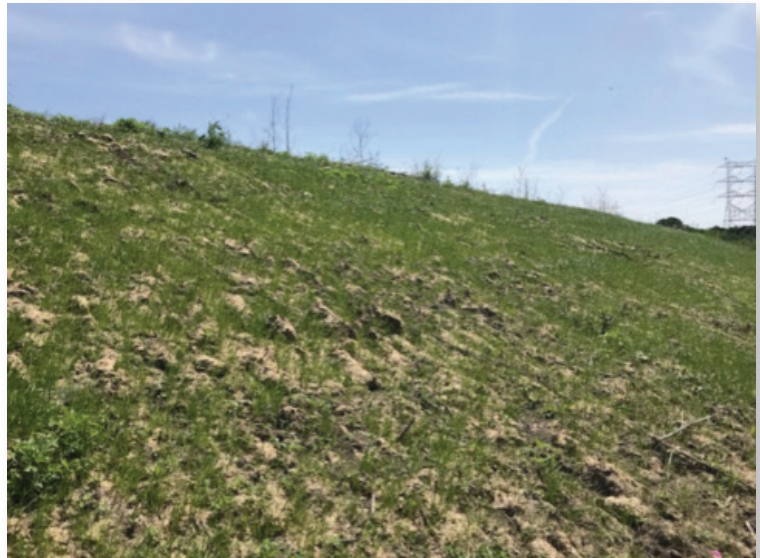
Significant vegetation achieved within one month of installation: April, 2018.

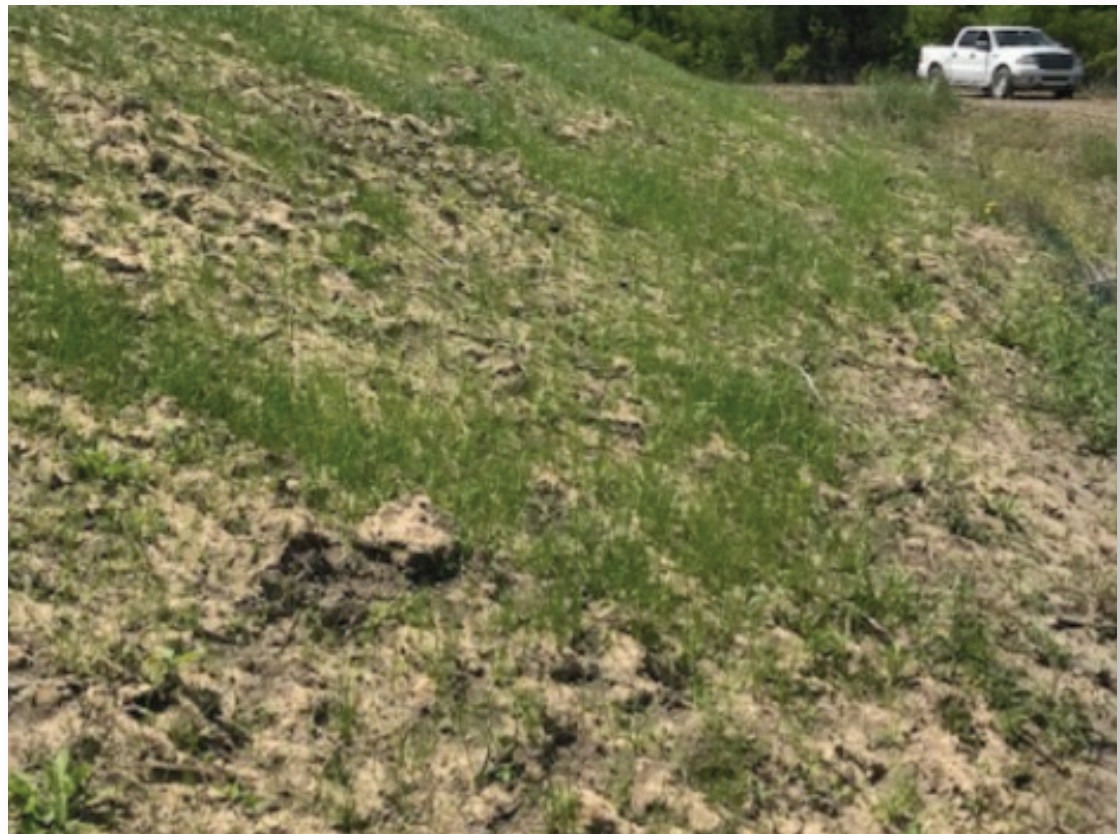
One month post installation .

Initial vegetation results far exceeded the previous one achieved without the use of Biotic Earth. Vegetation continues to come in and as of 3 months post installation already exceed 60% vegetation cover on the site.
